Case Study 3 – Explosion Incident

The *Cidade de São Matheus* (CDSM) is a floating production, storage and offloading (FPSO) facility.

Engineering Management Systems: Learning from experience

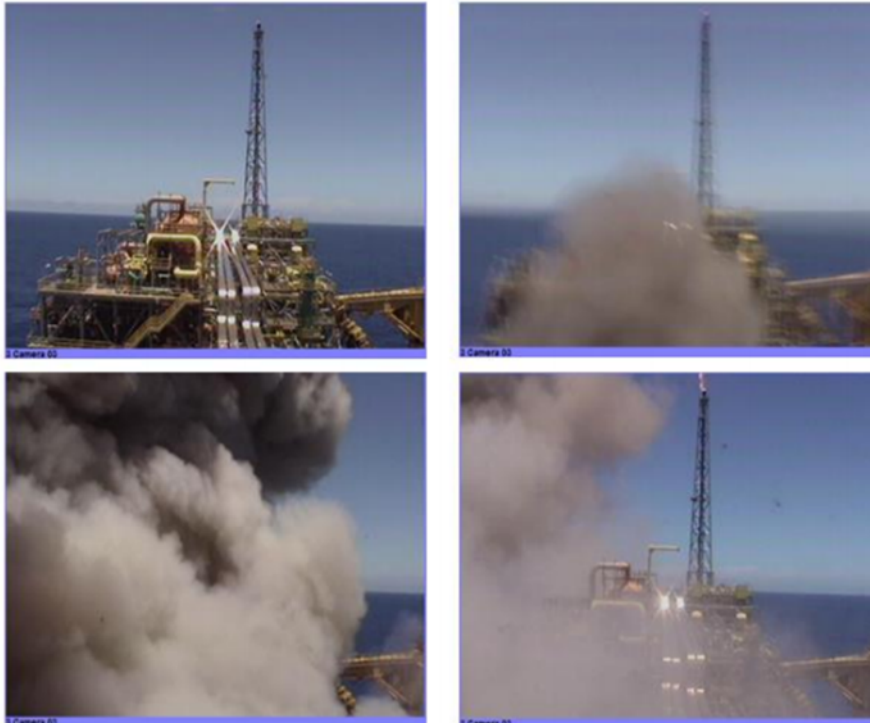
Figure 1 Photos from footage of the explosion

- That the leak was caused by a failed spade (blank) fitted to one of the pipe-flange connections.
- That the likely source of ignition was static electricity from the water jet.

The explosion ruptured the bulkhead between the pump room and the engine room, causing substantial damage to the pump room, engine room, the area near the entrance to the pump room access shaft and accommodation cabins. The cost of repairs was approximately USD 250 million.
