Case Study 5 – Structural – LGSF

Engineering Management Systems: Learning from experience

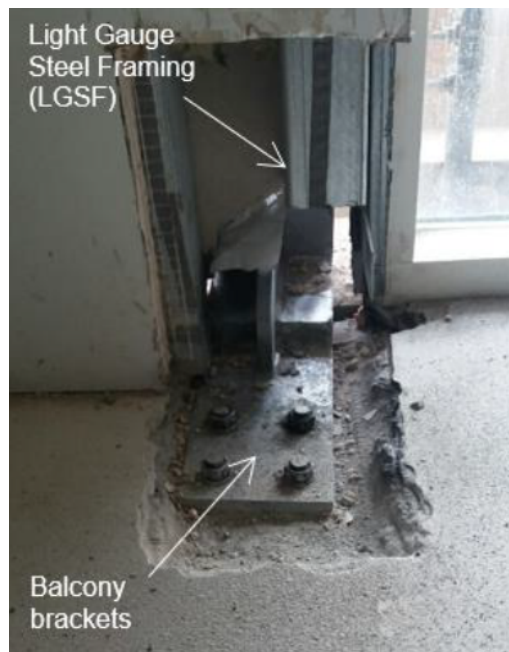
Figure 1 Balcony Frame Attachment and Main Structure / LGSF Notching

Balcony frames required notches in the main structure and LGSF jambs. However, the requirement for notches was not coordinated with the designer or LGSF sub-contractor and as such there were none.

To connect the balcony frames to the main structure, both the main structures and LGSF jambs were modified by the installer as shown in Figure 1. These modifications resulted in all structural loads on the LGSF jambs being supported only by the plasterboard façades.

If unnoticed, this fault could have resulted in structural failure of the LGSF jambs causing glazing and other finishes to fall onto people in the surrounding area.

- There was a failure to recognise at the design stage that provision would be needed to accommodate the balconies.
- The Principal Contractor failed to refer the issue back to the relevant designer once the problem became known and before allowing notches to be made.
- There were multiple sub-contractors and suppliers without one overall guiding hand.
- In any structure, the Principal Designer MUST ensure there is a viable load path which all parties understand and respect across all structural parts - whoever supplies them.

The LGSF sub-contractor was alerted to the occurrence and raised the issue with the supplier. A remedial design was produced to reconnect the LGSF jambs back to the main structure.
