Case Study 6 – Tower Crane Collapse

Background

A 79m high tower crane was being used as part of a project to build a new eight-storey hotel and seven apartment blocks in Liverpool, UK.

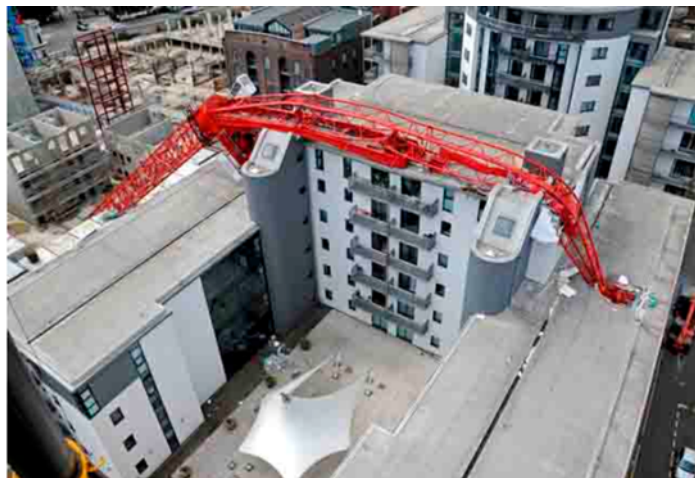
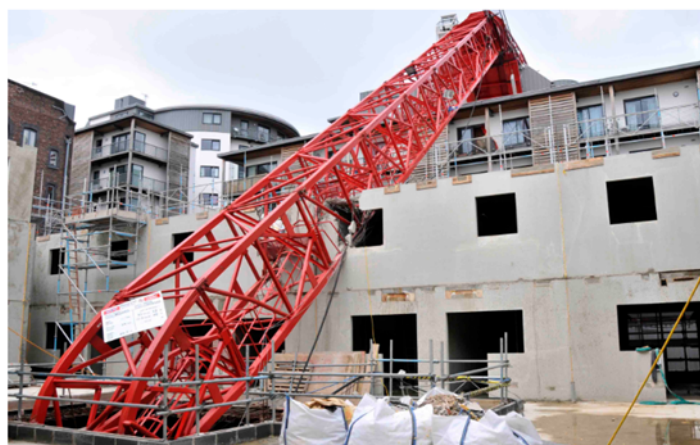
Figure 1 The toppled tower crane lays across residential apartments
