Case Study 4 – Winery Incident

Engineering Management Systems: Learning from experience

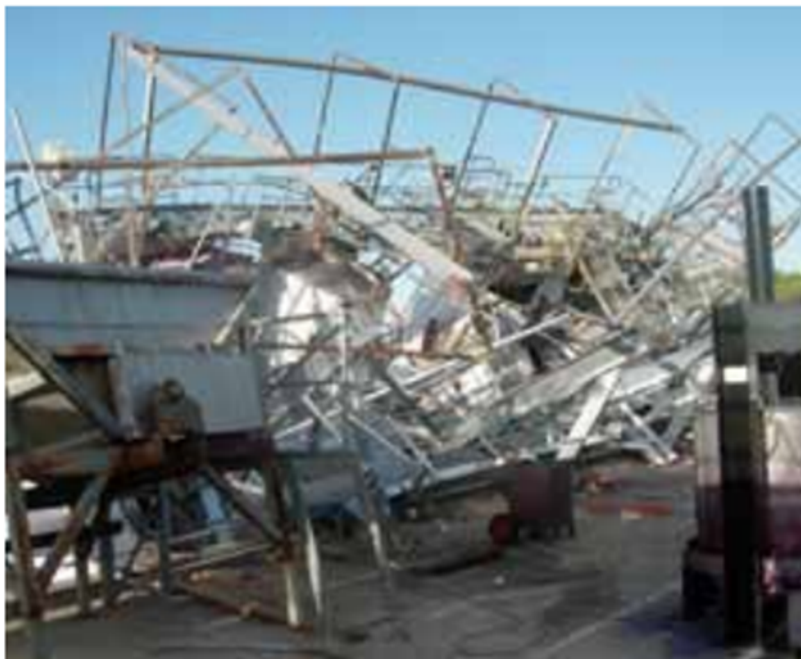
On March 8th, the new tanks were filled to capacity during normal production. The weight of the product caused the supporting structure to collapse which caused a cascading failure of the surrounding structures and equipment due to a “domino” type-effect. The entire production facility collapsed in less than 20 seconds.

Figure 1 Wirra Wirra Production Facility Post-Incident

- The tanks had been installed on an existing foundation slab in the production facility.
- There was no assessment of whether the foundation slab was suitable to support the new structure.
- The load applied by the tanks to the slab was five times greater than the slab was rated to withstand.
- The companies involved had failed to use a licensed building works supervisor for the installation.

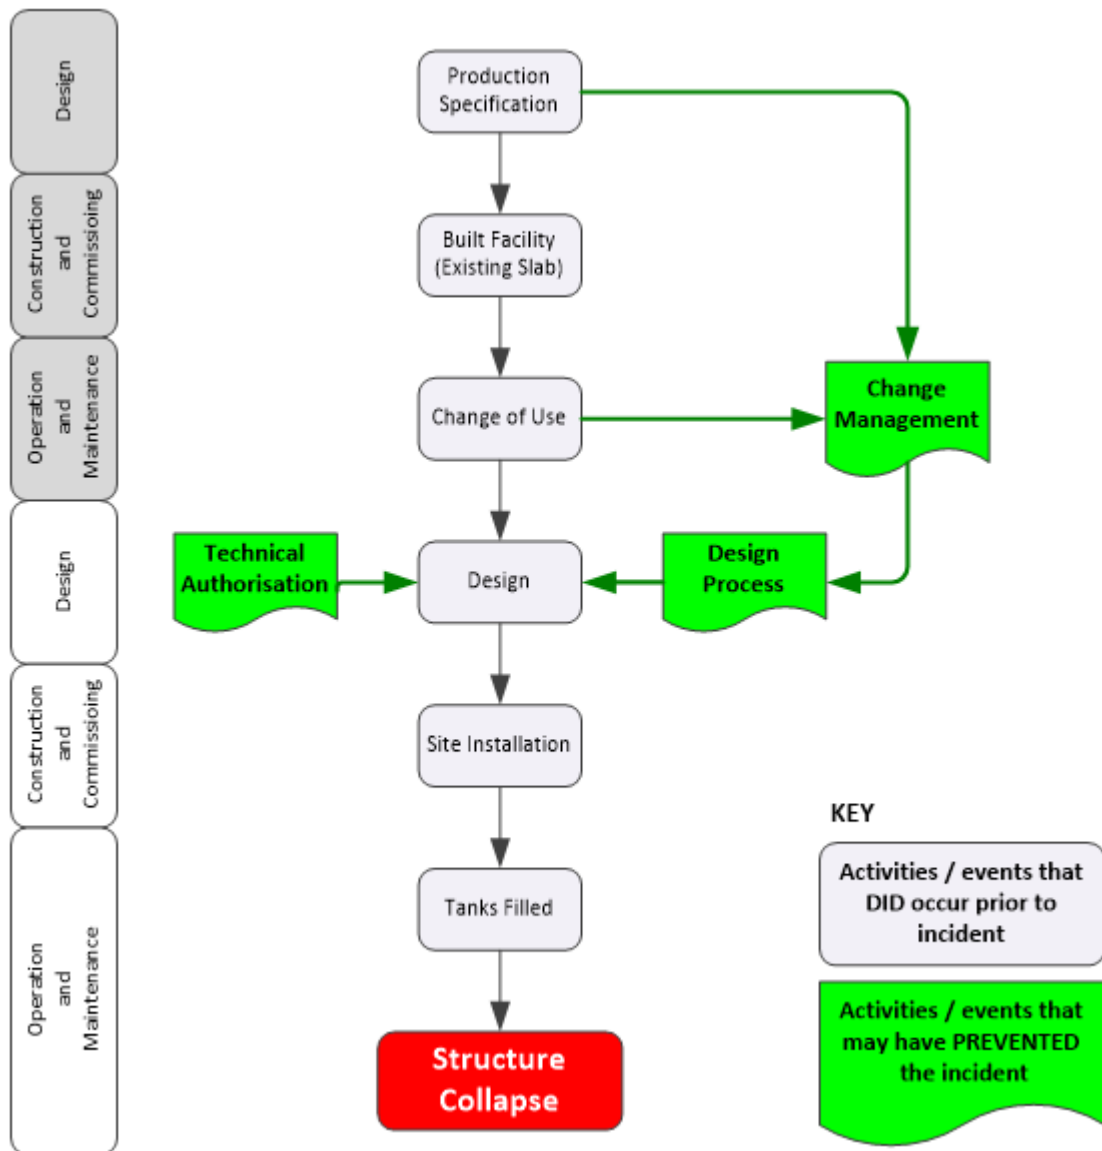
Figure 2 What engineering management activities may have prevented this incident?

Event	Applicable Engineering Process(es)	Discussion
Change of Use	Change Management	The change of use of the facility resulted in a change to the loading applied to the foundation. The tank loads were likely not considered during the original foundation design and as such the foundations were not fit-for-purpose. Change management would have identified that the foundations were not designed to support the type of loading that would occur due to the operation of the tanks.
Design	Design Process	The lack of a design process resulted in important design development tasks not being performed ; the design was not subjected to any review which may have identified the inadequate footing design / foundation capacity.
	Technical Authorisation	Those involved in the specification and manufacture of the tanks did not have the relevant skills to undertake the design. A technical authorization process would have identified that those involved did not have the required qualification, competence or experience to undertake the design.
